SOUND AGRICULTURAL PRACTICE
Opinion Number 19-1

SUBJECT: Request for an Opinion Pursuant to Section 308 of the Agriculture and Markets Law as to the soundness of the use of land for the production of field crops in relation to stormwater drainage within the Town of Royalton, Niagara County, New York.

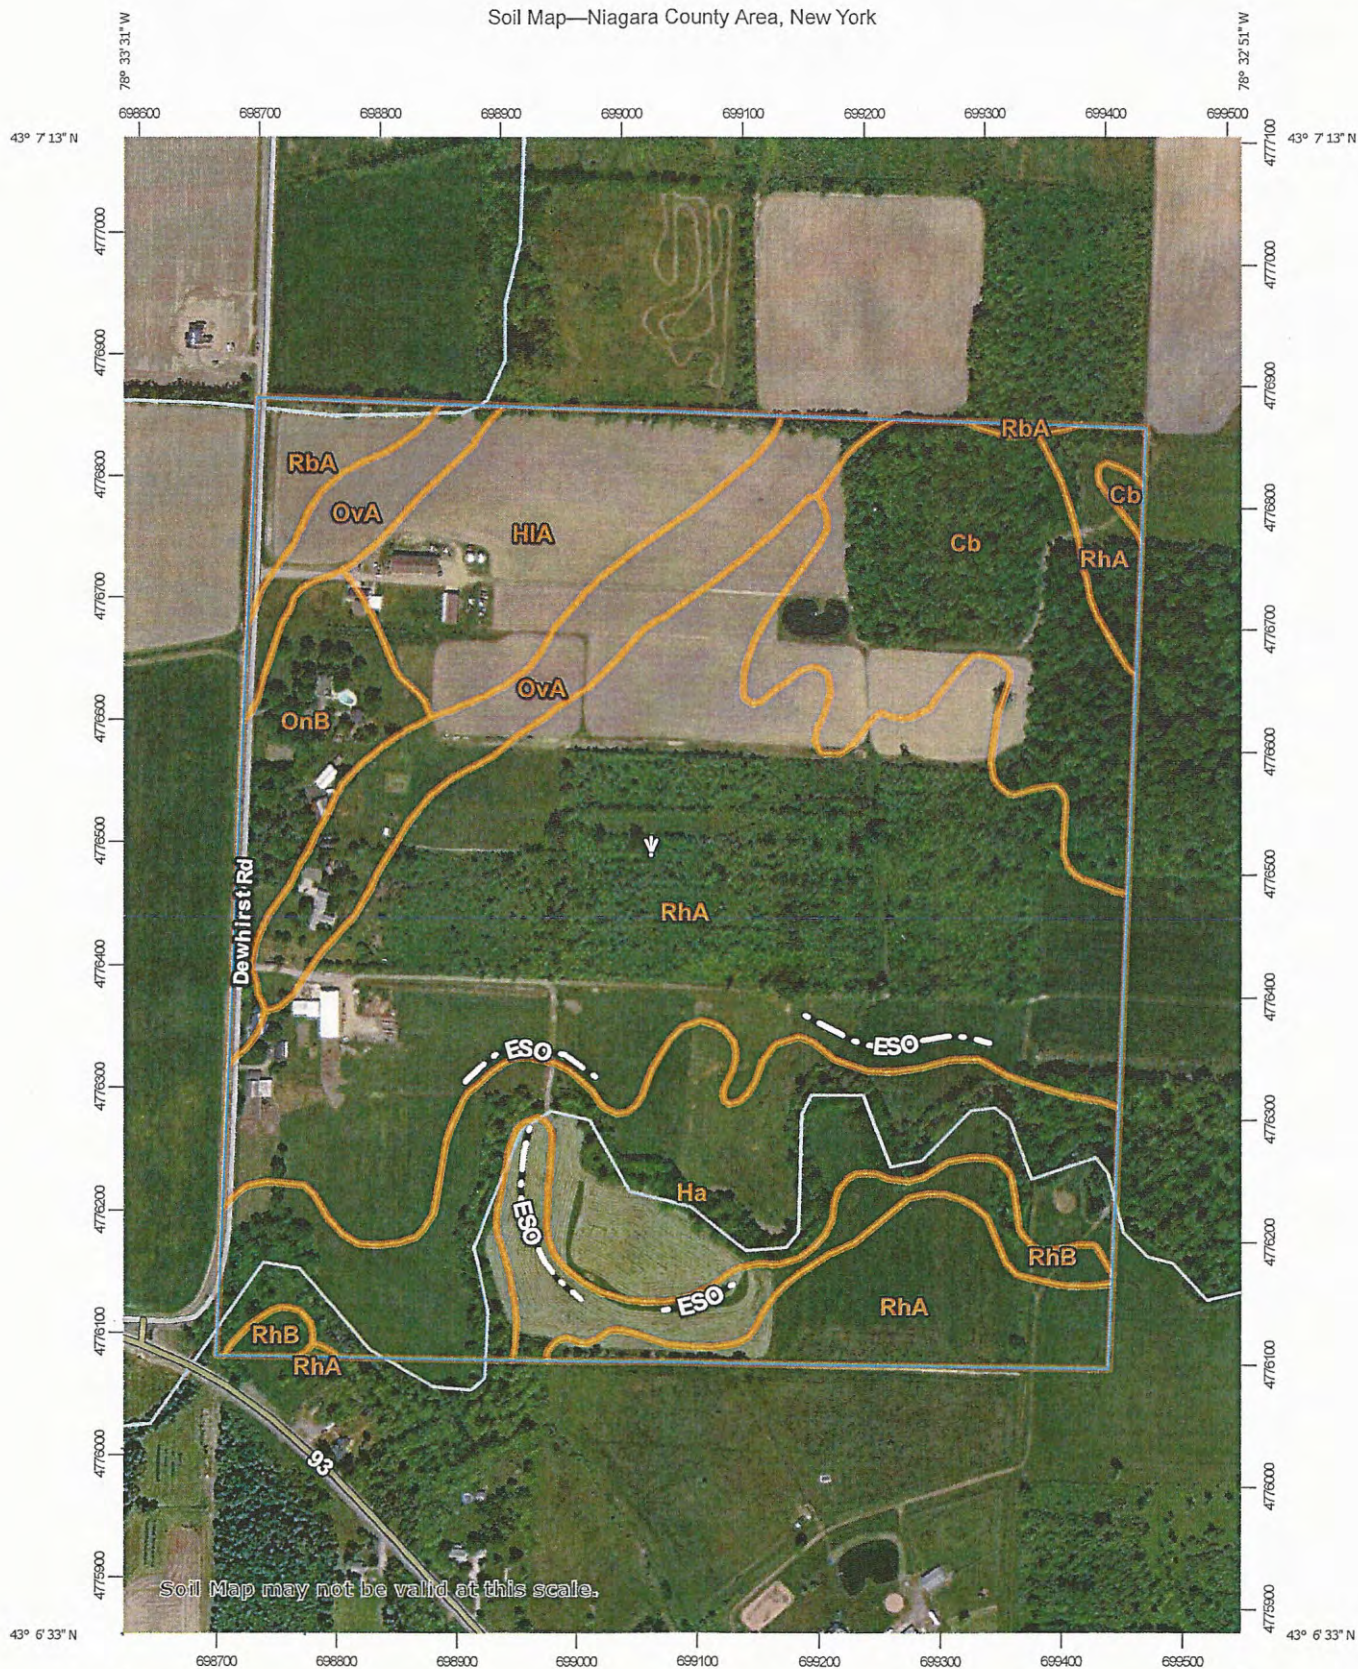
Soil Map—Niagara County Area, New York

16. According to the United States Department of Agriculture (USDA) Natural Resources Conservation Service (NRCS) soil survey for Niagara County, a majority of the soils on the Ohol and Stockwell parcels, consists of Hilton silt loam, Ovid silt loam, Canandaigua silty clay loam, and Rhinebeck silt loam (**APPENDIX C**)³. Except for the Hilton series, these soils are nearly level, somewhat to very poorly drained and have high water tables due to their clay dominated subsoil. The USDA states that farm development is limited by natural drainage and slow permeability. The survey states that farm development is limited without group drainage projects that provide suitable outlets for the surface water.

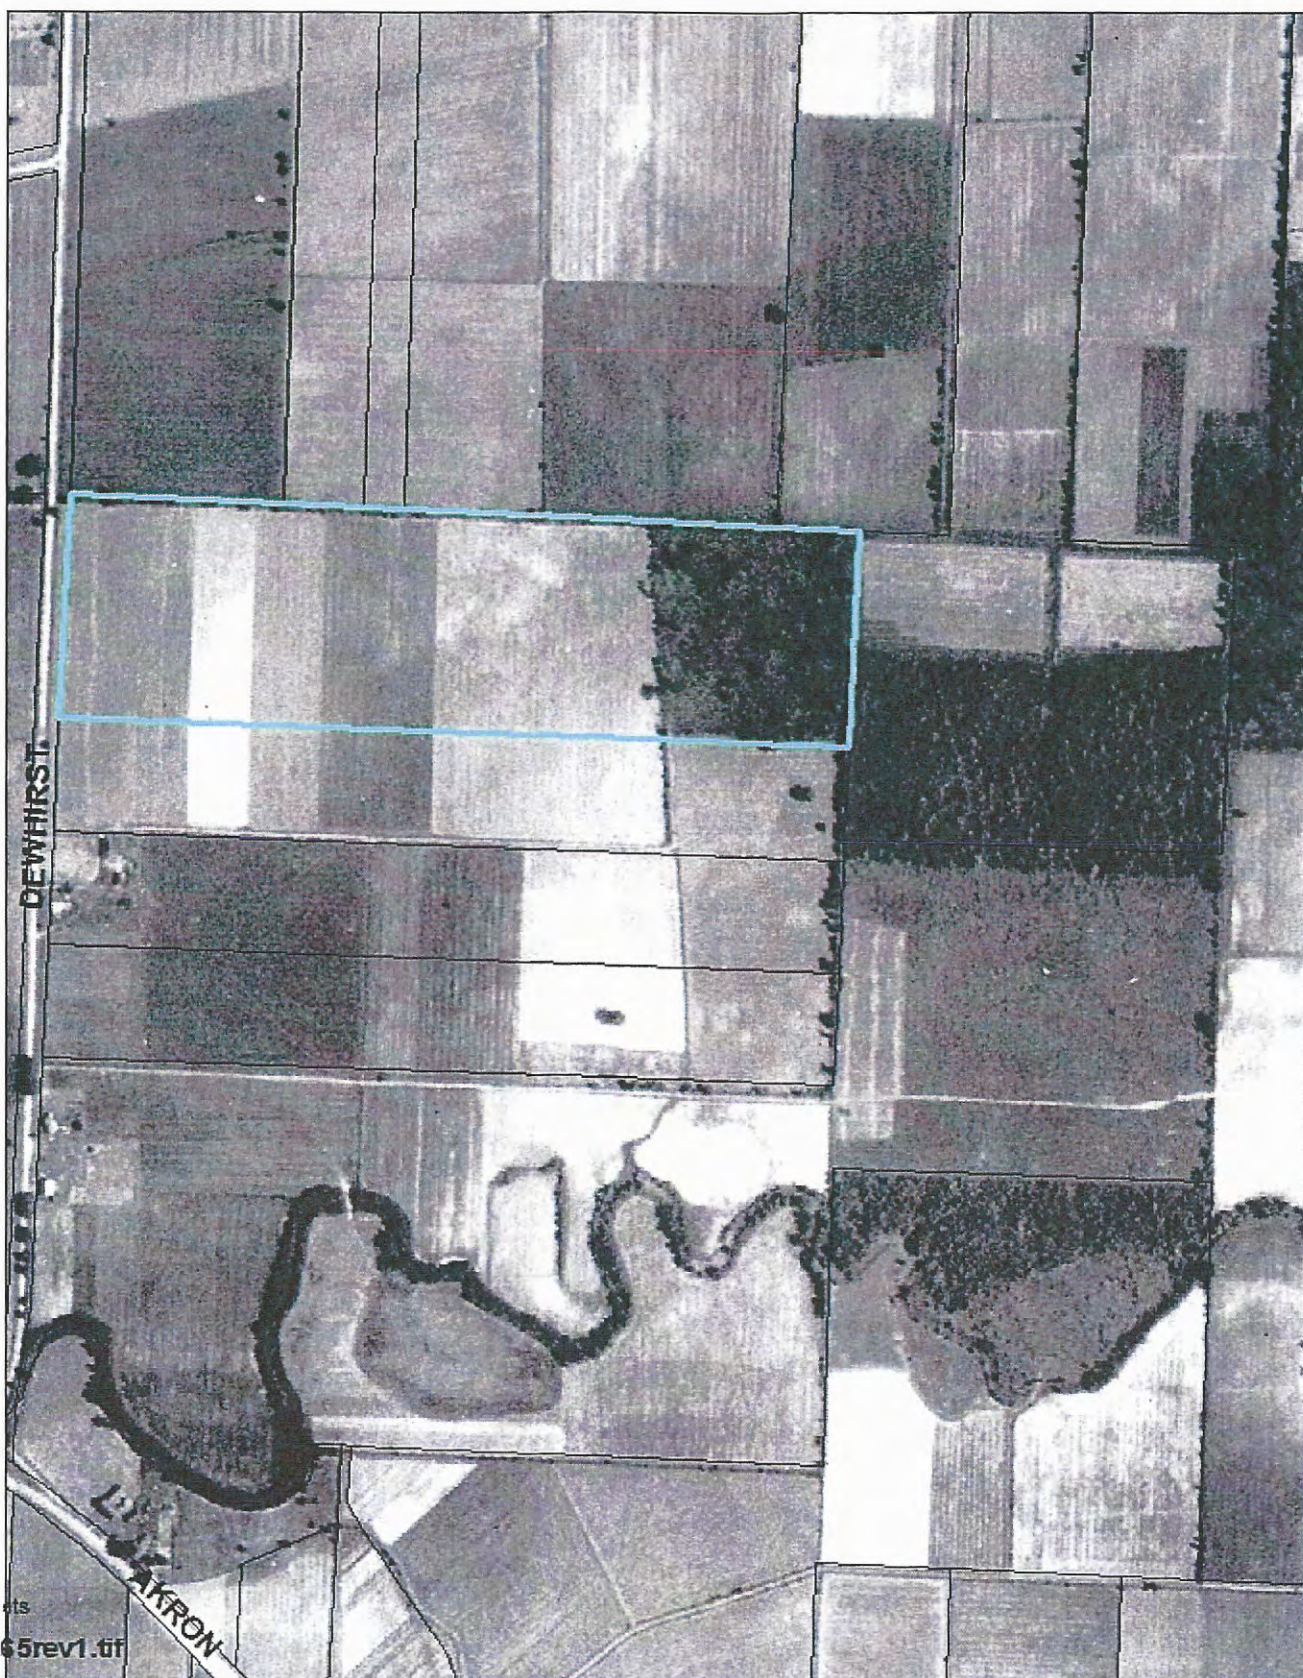
1938 Aerial

20. **APPENDIX F** contains a series of four aerial images as acquired by the Niagara County Highway Department (1938 image) and the U. S. Department of Agriculture (1951, 1995, and 2015 images). This imagery shows that the land uses have changed over time, but the same man-made channel/drainage ditch is clearly visible in every image, beginning with the oldest, 1938 image. It is unknown when the channel was constructed, but this ditch has been used for over 80 years to convey water from land within the watershed to Mudd Creek.

24. Department staff reviewed the four images contained in **APPENDIX F**, and concluded that almost all of the land within the watershed was used for the production of agricultural crops in 1938. In the 1951 image, the Ohol and Stockwell properties were being farmed as one unit and were probably part of the same parcel. The 1995 image shows that a new drainage ditch was constructed sometime between 1951 and 1995 behind the house now owned by the Kauschingers. The drainage ditch traverses that parcel of land in a west to east direction. The status of that ditch is unknown. Land currently owned by Stockwell, McGirr and Kauschinger partially reverted to woody vegetation as depicted in the 1995 image (**APPENDIX F**). This successional regrowth of woody vegetation is evident in the 2015 image for the McGirr and Kauschinger properties. Sometime between 2002 and 2006, the Stockwell property was cleared and placed back into agricultural production (**APPENDIX H**). The Thomas Stockwell parcel and the Steven Ohol parcel, as well as land north of these parcels, continue to be used for agricultural purposes.

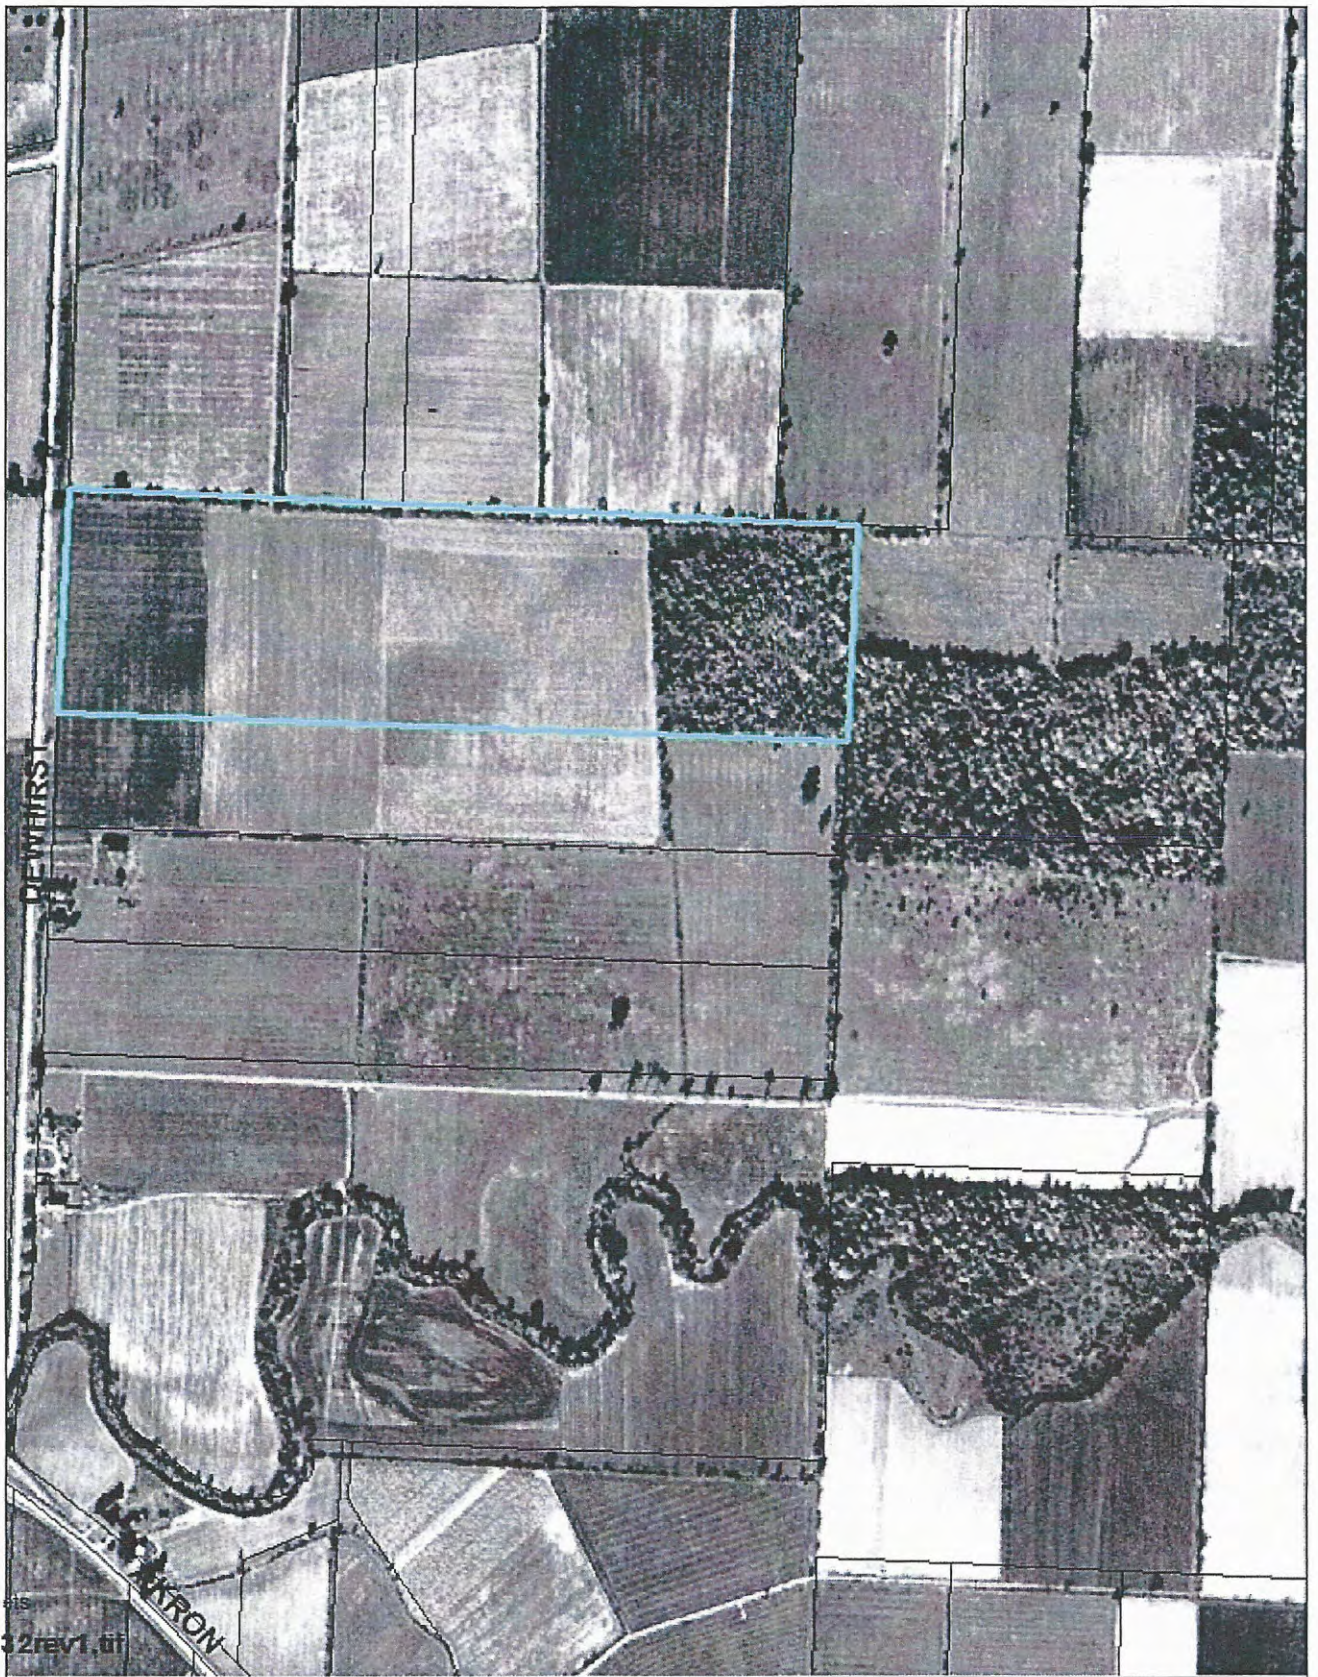
1951 Aerial

21. The 1951, 1995 and 2015 images also depict another drainage ditch to the west of, and parallel to, the disputed drainage channel. This drainageway also receives a portion of the surface and subsurface water within the watershed and conveys that water to Mudd Creek. The land within this region is fairly flat, consists of lake plain sediments, and is poorly drained. Artificial drainage and man-made channels move water to downslope positions, making the soils suitable for the production of agricultural crops. These man-made drainage facilities can also be viewed from a 2008 image acquired by the U.S. Geological Survey (USGS) and available on google earth (**APPENDIX G**).
